V-UMP9-RK REPAIR/MAINTENANCE MANUAL

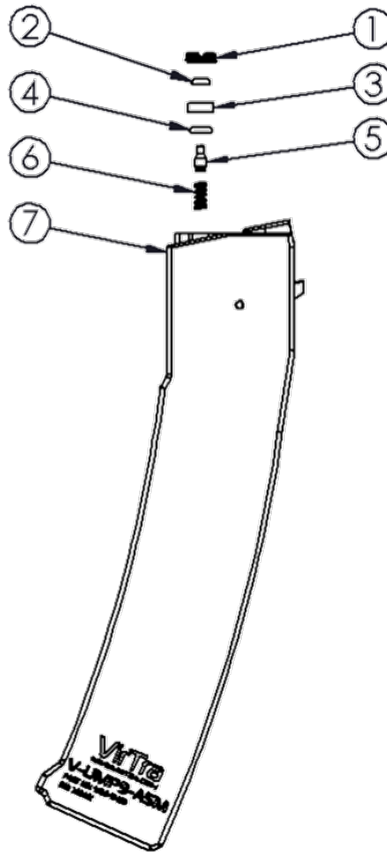
Figure 3: Double Seal Assembly

ITEM NO.	DESCRIPTION
1	Double Seal Cap
2	Top O-Ring, 005
3	Double Seal Spacer
4	Bottom O-ring, 007
5	Double Seal Valve
6	Compression spring
7	Magazine Body

- Remove the double seal cap (Figure 3, #1) using a thick blade screwdriver.
- Use a small pick or screwdriver to remove the 005 O-ring (Figure 3, #2) and double seal spacer (Figure 3, #3). Inspect the O-ring and replace if any damage/wear is present.

- Use a small pick or screwdriver to remove the 007 O-ring (Figure 3, #4). Inspect the O-ring and replace if any damage/wear is present.
- Invert the magazine and allow the double seal valve (Figure 3, #5) and compression spring (Figure 3, #6) to drop free. Inspect the spring and replace if any damage/wear is present.

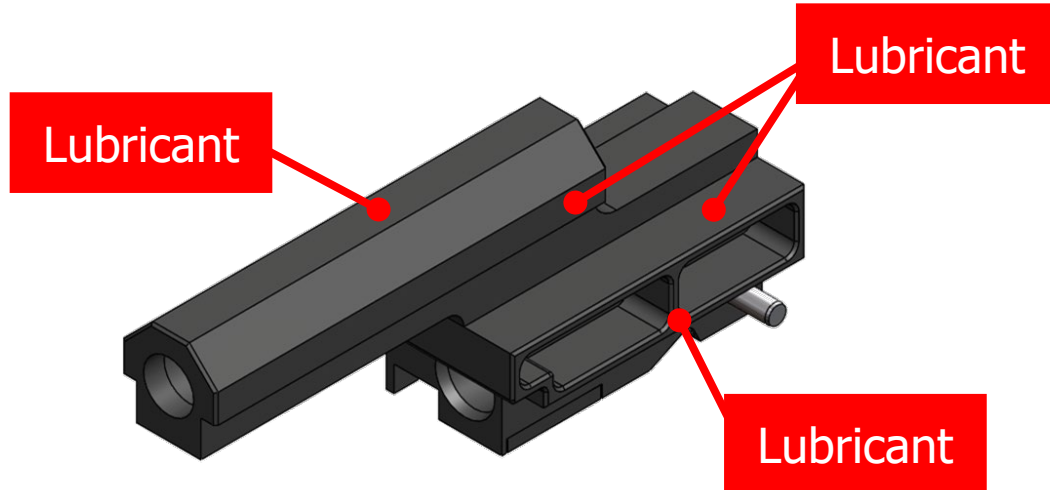
Figure 4: Bolt Carrier Lubrication 1

Using a cotton swab or microfiber cloth apply approximately half a drop of approved lubricant (Slip 2000 or Lucas Oil) to the locations shown in the following figures.
