V-UMP9-RK REPAIR/MAINTENANCE MANUAL

I. RECOIL KIT COMPONENTS

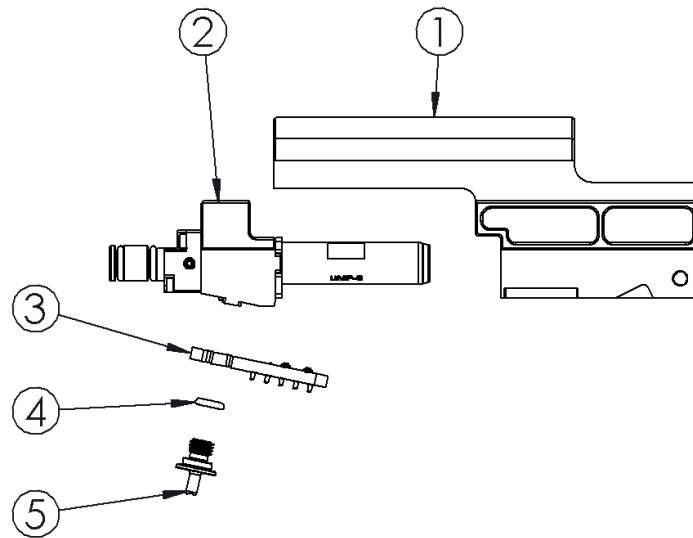
Figure 1: Recoil Kit Assembly

ITEM NO.	DESCRIPTION
1	Bolt Carrier
2	Charge Chamber Assembly
3	Retaining Plate
4	Nipple O-Ring, -008
5	Charge Chamber Nipple

If a leak is experienced when the magazine is inserted into the weapon, and the leak is not coming from the magazine, then items #6 and #7 in Figure 2 and #4 in Figure 1 may be leaking and in need of replacing. If it is determined that a leak is occurring within the recoil kit, follow the steps below. If applicable. Remove the recoil kit from the weapon prior to proceeding.

Reassemble the weapon and test. If a leak is still experienced, use the following steps to replace item #4 in Figure 1.

- Use the Nipple Tool to remove the charge chamber nipple (Figure 1, #4).
- Remove the retaining plate (Figure 1, #5) and use a small pick to remove the 008 nipple O-ring. Inspect the O-ring and replace if any damage/wear is present.
- Reassemble in reverse order.

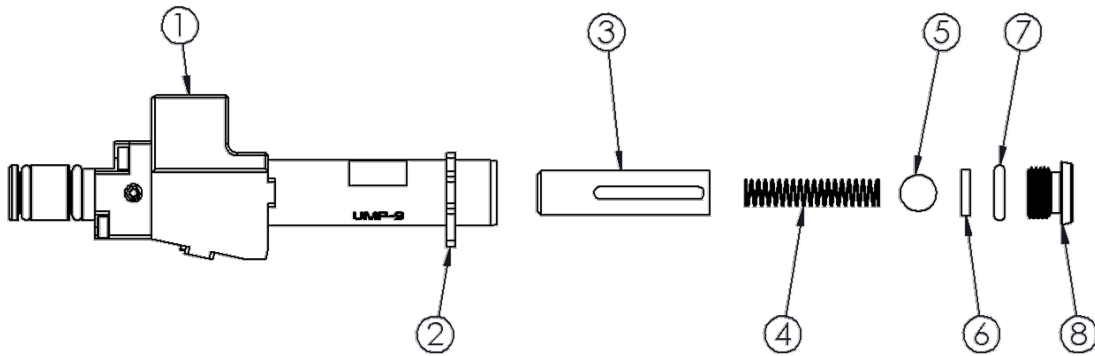
Figure 2: Charge Chamber Assembly

ITEM NO.	DESCRIPTION
1	Charge Chamber
2	Bolt Carrier Bumper
3	Inner Air Chamber
4	Compression Spring
5	Ball Bearing, 1/4" DIA
6	Charge Chamber Ball Bearing Seal
7	Endcap O-Ring
8	Charge Chamber Endcap

- Use a 5/32 Allen Wrench to remove the charge chamber cap (Figure 2, #8).
- Use a small pick to remove the Endcap O-ring (Figure 2, #7) and the Charge Chamber Seal (Figure 2, #6). Inspect both items and replace if any damage/wear is present.

- Cover the open end of the charge chamber then rotate the charge chamber till vertical and allow the ball bearing, compression spring, and brass Insert (Figure 2, #5, #4, #3) to drop free. Inspect the compression spring. If the compression spring shows wear, damage, or if the ball bearing is wrapped into the coils, replace the compression spring. Contact the VirTra Service Department for further assistance.
- If any of the internal items are dirty or contain debris, wipe them clean with a soft clean cloth.
- Place the brass insert, compression spring, and ball bearing back into the charge chamber.
- Place the charge chamber ball bearing seal into the charge chamber. Ensure the chamfered side (angle cut) faces the ball bearing.
- Screw the charge chamber cap back onto the charge chamber, taking care not to overtighten.
